Manhole Inspection Summary

Manhole # S45C2_033MH

Location Address: **3607 Everett St** Cross Street: **Cambria-Pontiac**

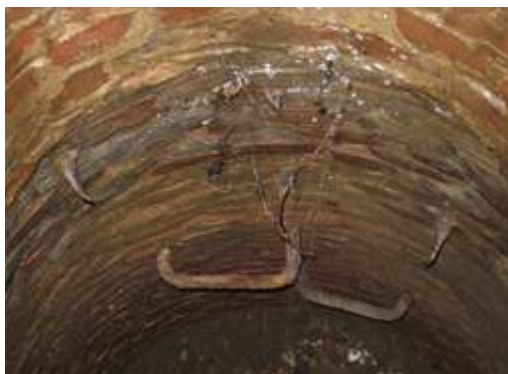
Steps Count: **4** Missing: **2** ☒ **Corroded**

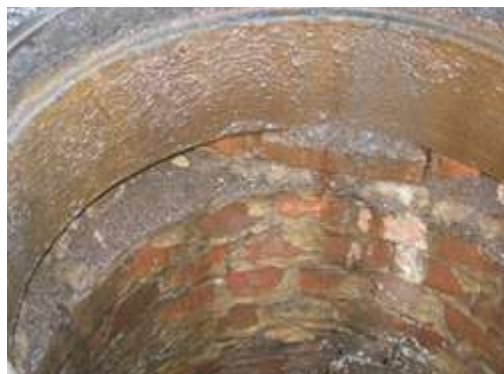
Defect 2

Chimney / Frame Adjustment ☒ Exists Material: **Brick** ☐ Parged Height: **10** (in.)
Condition: ☐ Sound ☐ Cracked ☐ Root Intrusion ☒ **Loose Brick** ☐ Deteriorated
Infiltration: ☐ None ☐ Joint ☐ Cracks ☒ **Mortar** ☐ Roots ☐ Wall

Loose bricks

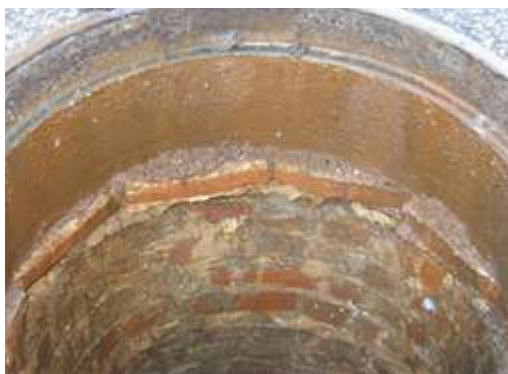
Defect 1

Frame Offset: **1** (in.) Condition: ☒ Sound ☐ Cracked ☐ Leaks

Frame offset

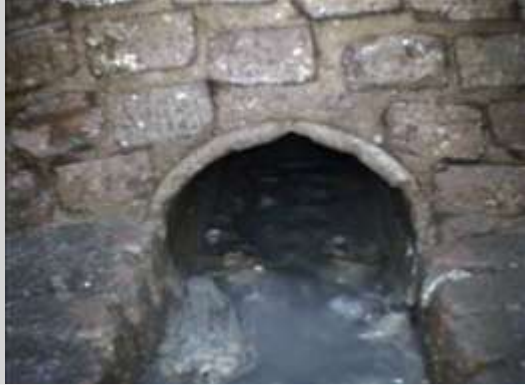
12 O'Clock Outflow

8 in. Circular Gravity Sewer
Pipe Out @ 12 O'Clock

Pipe Height: **12** (in.) Rod and Bar (Angled)
Pipe Material: **Clay** ☐ Pipe Lined
Invert Depth: **9.42** (ft.) Flow Characteristics: **Slow**
Deposits: ☒ None ☐ Mud ☐ Sludge ☐ Debris ☐ Grease
Silt Depth: (in.) Deposits Extent:
Infiltration: **None** Pipe Seal Cond: **Sound**

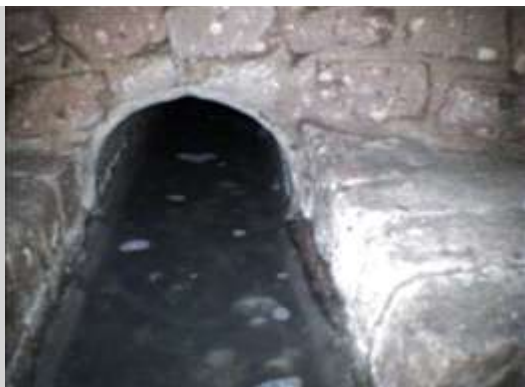
6 O'Clock Inflow

8 in. Circular Gravity Sewer
Pipe In @ 6 O'Clock

Pipe Height: **13.2** (in.) Rod and Bar (Angled)
Pipe Material: **Clay** ☐ Pipe Lined
Invert Depth: **9.44** (ft.) Flow Characteristics: **Slow**
Deposits: ☒ None ☐ Mud ☐ Sludge ☐ Debris ☐ Grease
Silt Depth: (in.) Deposits Extent:
Infiltration: **None** Pipe Seal Cond: **Sound**

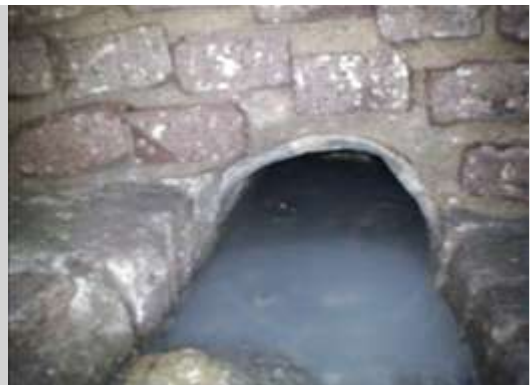
8 O'Clock Inflow

8 in. Circular Gravity Sewer
Pipe In @ 8 O'Clock

Pipe Height: **8.4** (in.) Rod and Bar (Angled)

Invert Depth: **9.45** (ft.) Flow Characteristics: **Slow**

Infiltration: **None** Pipe Seal Cond: **Sound**
